New York, New Haven & Hartford Railroad:  
Stamford Station  
44 Station Place  
Stamford,  
Fairfield County,  
Connecticut

HAER No. CT-9

# NORTHEAST CORRIDOR IMPROVEMENT PROJECT

### STAMFORD STATION AND STAMFORD STREET RAILROAD TROLLEY BARN AND OFFICE BUILDING

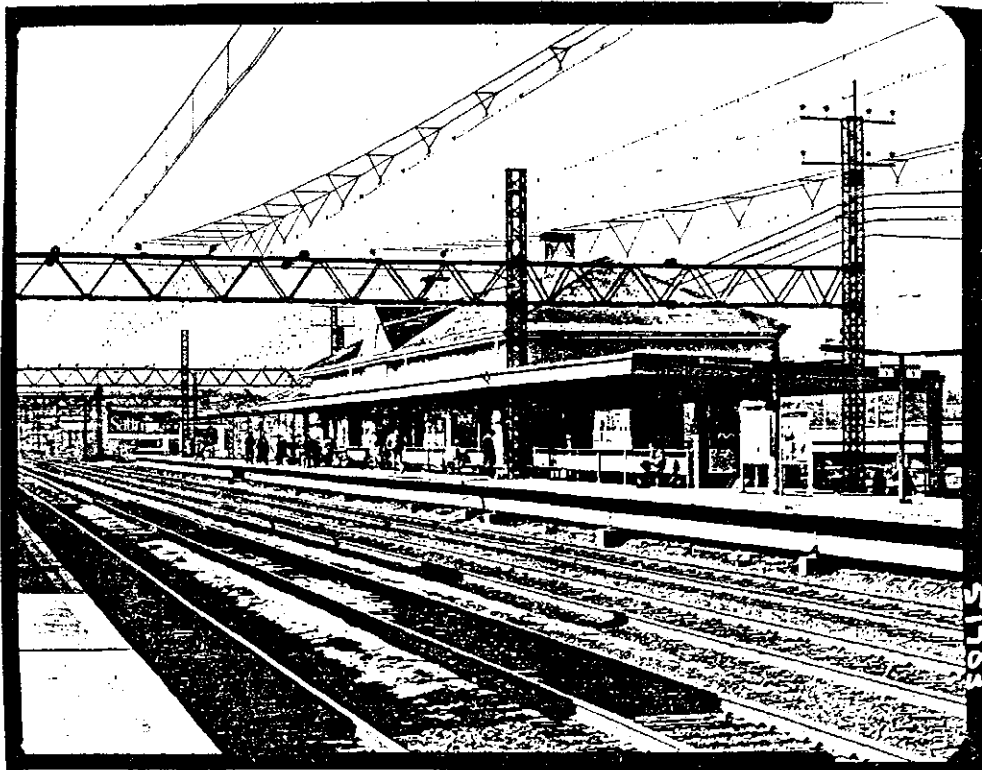
✓ Photo 2  
Stamford Station: View of north (westbound) station platform.  
Note triangular catenary hangers.  
Photographer, Wm. Edmund Barrett, 1983

In October 1907 Stamford became the terminus for the first U.S. mainline electrically-operated passenger train service when the NY,NH&H Railroad was electrified between Woodlawn, New York and this point.<sup>7</sup> Steam locomotives were attached to all trains going east beyond Stamford. This designation as a terminus was important to the economic growth of Stamford as a regional center in southwestern Connecticut. The superior commuting service of the electrified line was cited in 1929 as directly contributing to a doubling of Stamford's population between 1905 and 1925, and a trebling of the number of commuters using the Stamford Station.<sup>8</sup> Even when electrification was completed beyond Stamford to New Haven in 1910,<sup>9</sup> the station remained a terminus of the electrically operated suburban train service from New York City. It continues to serve today as an important stop for both Metronorth suburban and Amtrak intercity service (Photo 2).

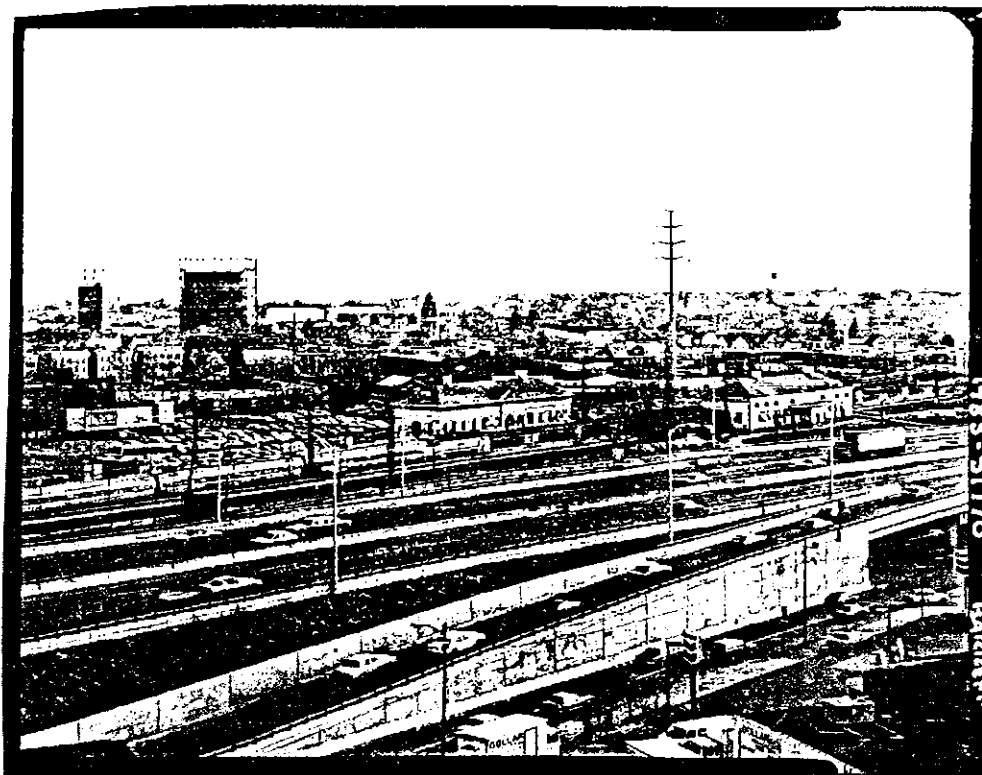
✓ Photo 3  
Stamford Station: View to south, showing twin stations, with  
Connecticut Turnpike in foreground.  
Photographer, Wm. Edmund Barrett, 1983

eastbound (New Haven) traffic; the north side is for westbound (New York) traffic (Photo 3). One low-level platform served passengers in each direction. Each building was capable of independent operation, including ticket sales. The buildings are sited in an offset relationship and linked by a subway passageway located between the near ends of the buildings. The subway is accessible only from stairways outside the buildings.

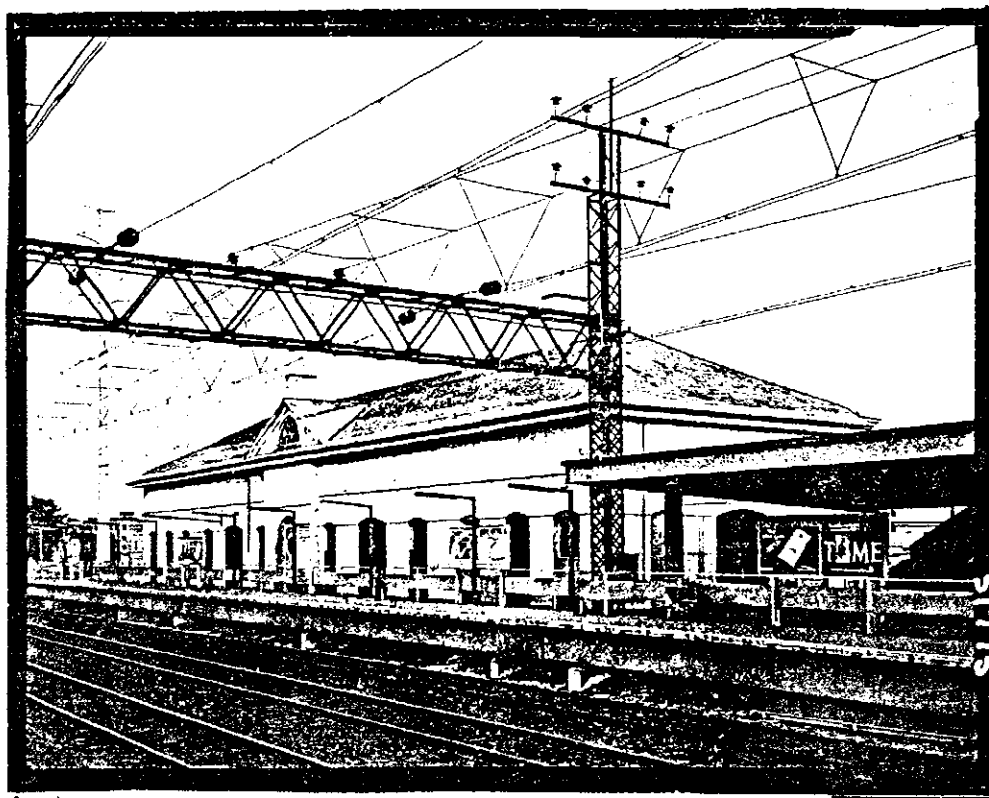
✓ Photo 10  
Stamford Station: South Station from tracks, illustrating high-level platform and catenary portal bridge.

The building exterior is yellow brick with red sandstone base and red sandstone window sills. The cornice and window frames are wood. The buildings were originally unpainted, but now are painted a light green color. The original plans show a slate roof; however, the hip roof was covered with yellow asbestos shingles. The ridge and hipcaps are red terracotta, while the chimneys, also painted, are of red brick (Photos 9, 10, 11).

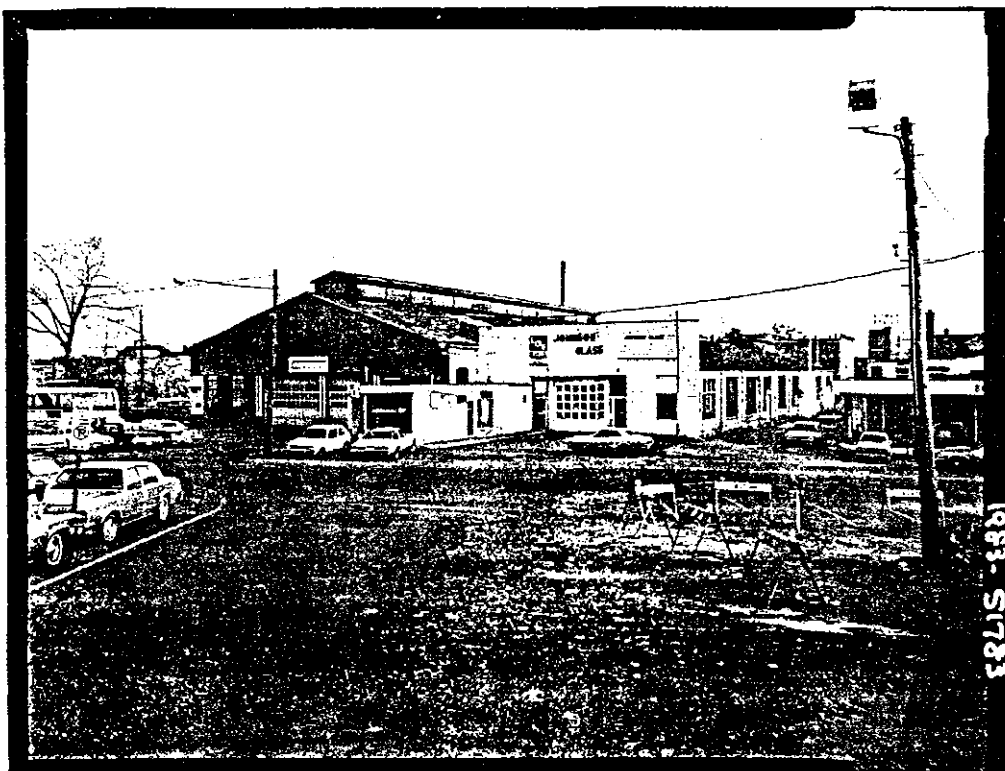
Photo 18  
Stamford Street Railroad Company Trolley Barn: View to south.  
Note 1924 addition on west.

An addition to the west facade of the barn was constructed in 1924 to accommodate buses. The structures served both trolley and bus functions until November 1933 when trolley service was discontinued. At that time the Connecticut Transit Company acquired the original trolley structure to house its buses,<sup>15</sup> and for all practical purposes abandoned the structure to the west (Photo 18).
